“Mods to Tantaliza”

Tantaliza was built in 1973 and she is a standard E30, as finished by the Peter Webster yard. The engine is a 10 h.p. Bukh. We bought her in 1975. She has been based in North Wales until 1998, and now she lives in Ardfern, Argyll. Her cruising area has been Wales, Ireland, South West coast of England, 3 trips to Brittany, and innumerable to or in Western Scotland. Our cruising is easier now, just wandering around lochs and islands, with no long passages.

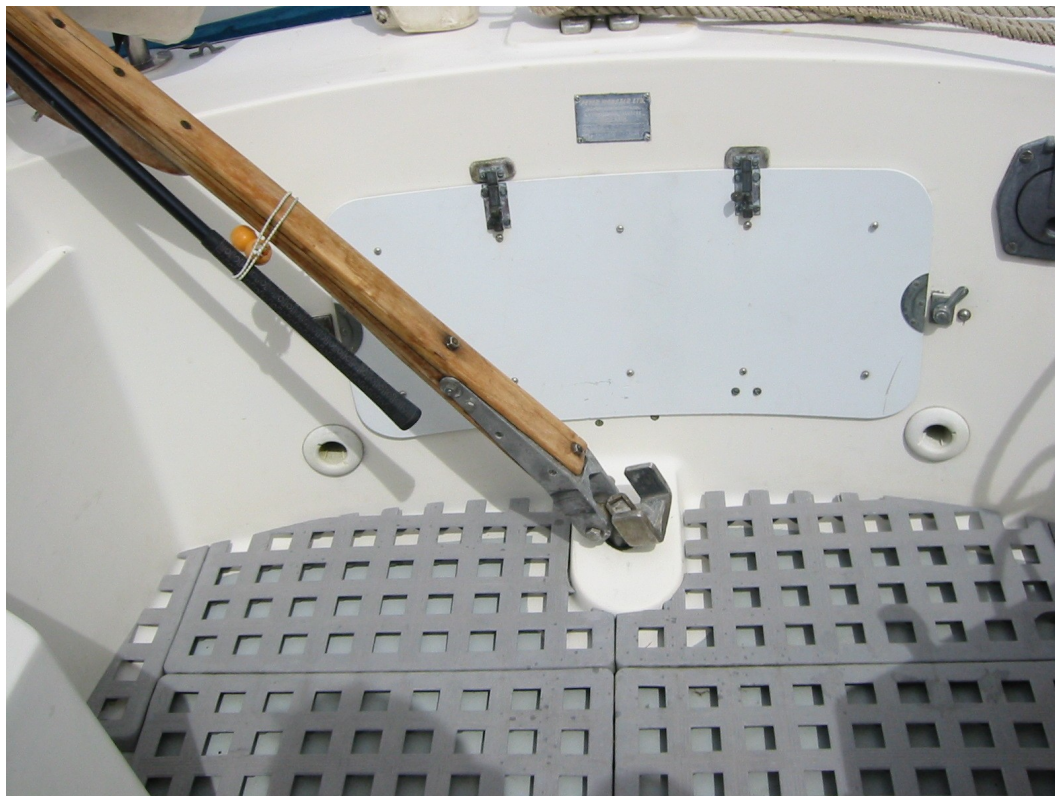
Following news of the Fastnet disaster, I was still concerned at the time it may still take to drain a flooded cockpit, and added two “spill” drains, straight through the transom. These are made up from plastic hull fittings, connected by tubes.

This shows the transom drains, from the inside. Incidentally, this shows the old flooring (industrial PVC). It has now been replaced with B&Q patio decking material. Re. the tiller fitting – see later

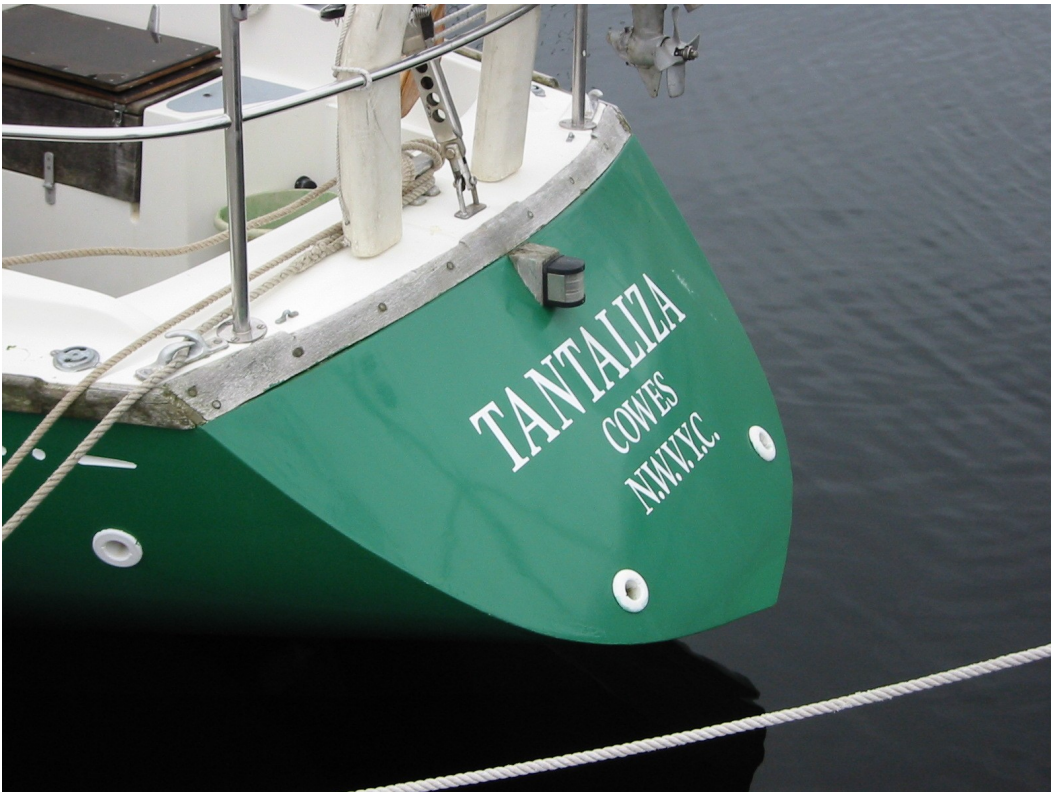
Transom drain from outside.

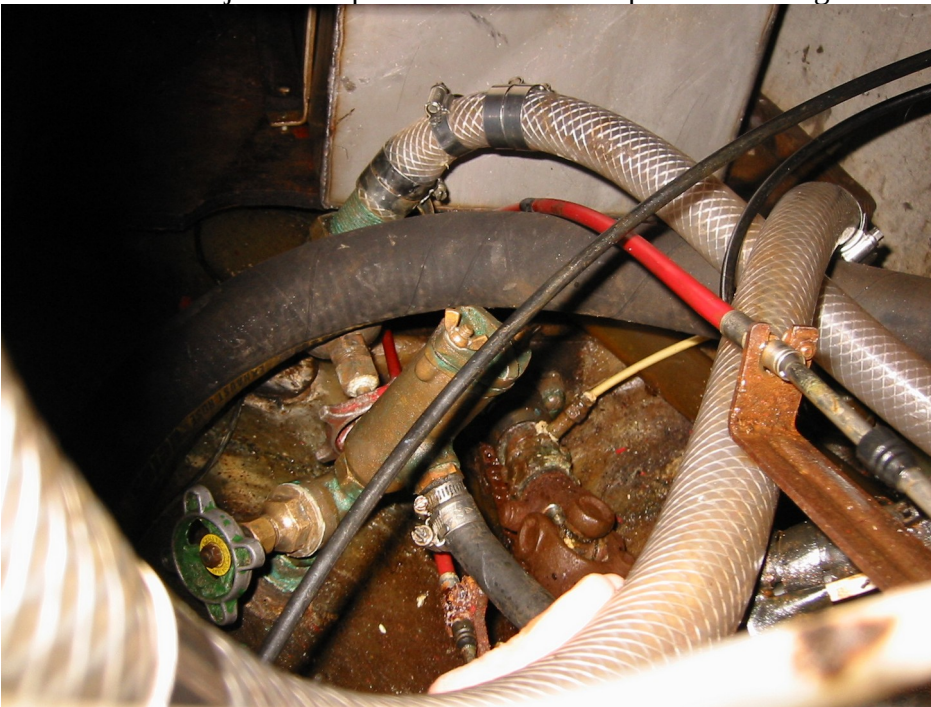
This picture shows the horrors to be encountered aft of the engine (10 HP Bukh with dynastart). Note: Braided cockpit drains, crossed over. Black rubber exhaust. Universal joint in prop shaft. Stainless fuel tank made to replace horrible rusted mass, which the original plain steel tank turned into. The “extra” jubilee clips on the drain hoses prevent kinking.

A new shaft was made out of stainless. This was “dumbbell” shaped, only reaching its full diameter at the ends (stern bearing and forward seal). This allowed some free “float” within the sterntube. At the forward end a relatively crude universal joint was fit, to give some degree of freedom. This universal joint is attached at one end to the shaft, and at its other end to a very short stub rod fixed into the flanged fitting at the back of the gearbox. One end of the universal simply clamps on the shaft, and it started to skid. I then drilled through and bolted it. The Universal joint does not fit absolutely tru on the end of the shaft, and to obtain alightment, some bits of mini-hacksaw blade have been inserted on one side where the flanges connect at the back of the gearbox. TW Marine where I get my stuff says only use monograde oil in the gearbox – which can he the same as the engine (straight diesel 20, still available from specialist suppliers).

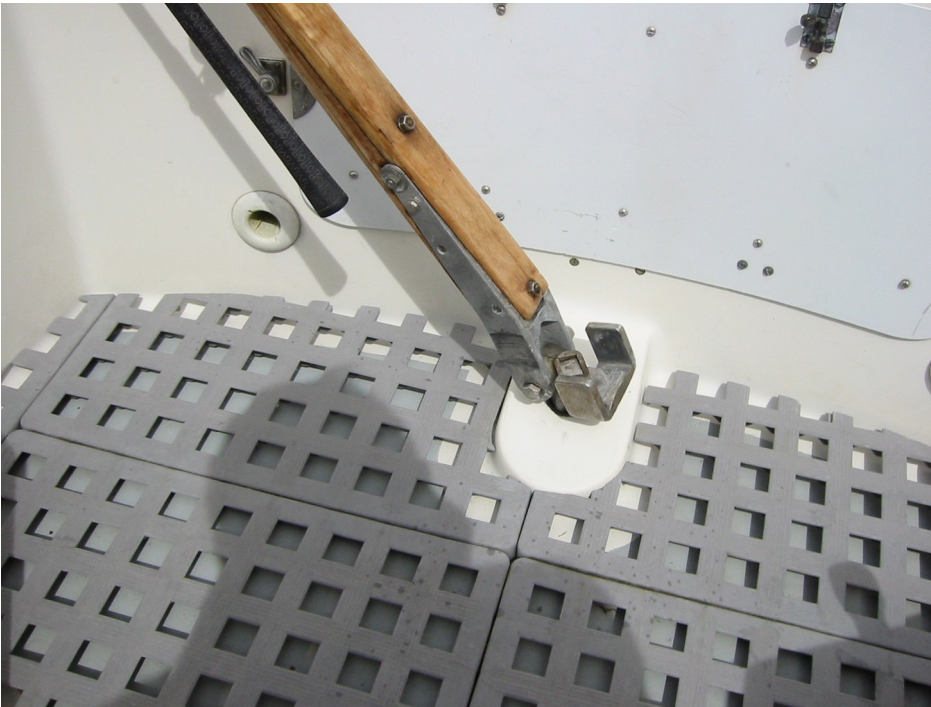
The original very pretty tiller fitting and tiller were already on the way out at 2 years old. A new tiller was laminated up – a bit longer and with a but more curve to it, The fitting was modified with welded “ears” at the top of the rudder stock. See pic:

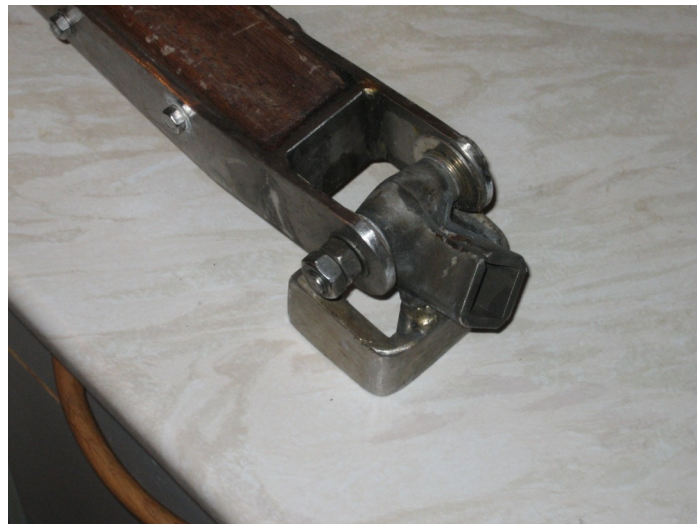
Picture:

Subsequently a second tiller has been made (2007), replicating the cast portion of the fitting at the top of the rudder stock, in stainless. (Drawing available). The original has been kept as a spare tiller. I was unhappy about the danger of cracking in the, now very ancient, cast aluminium “ears” on the original fitting, since tightening flexed them.

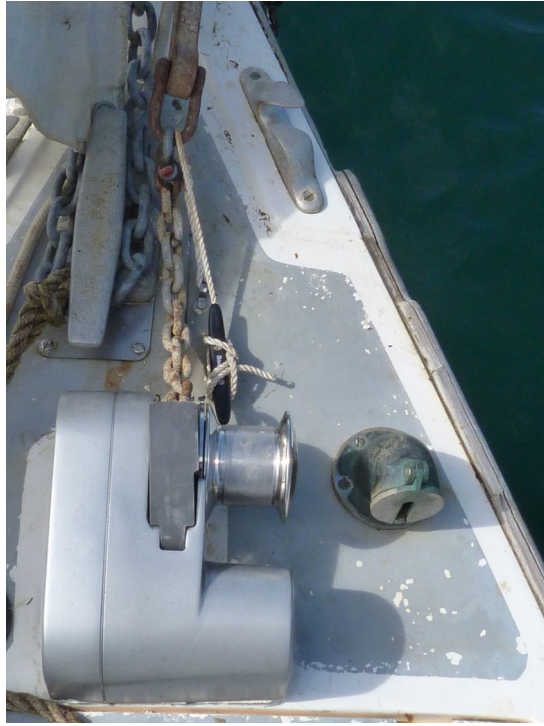
Here is the windlass, with the original windlass drum .

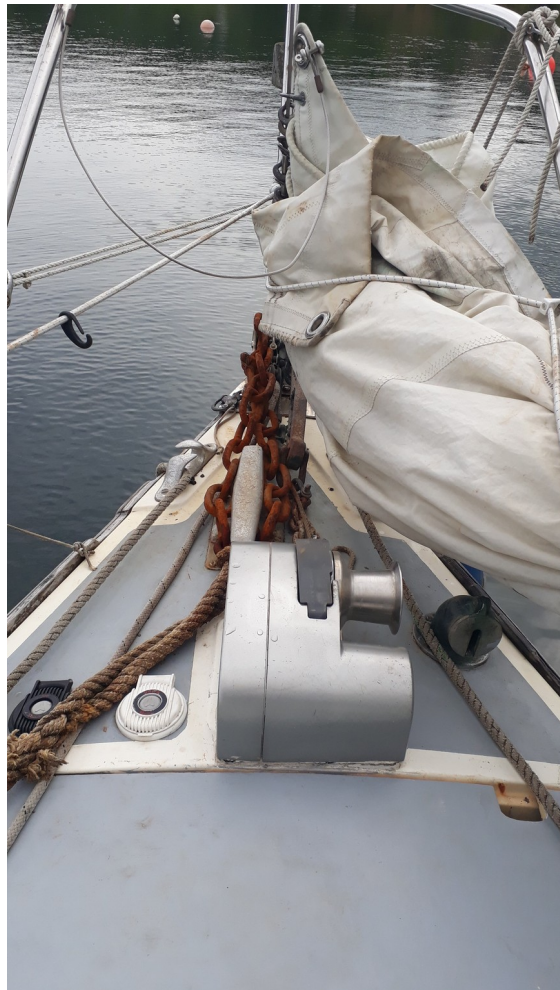
And here is the windlass with the new drum::

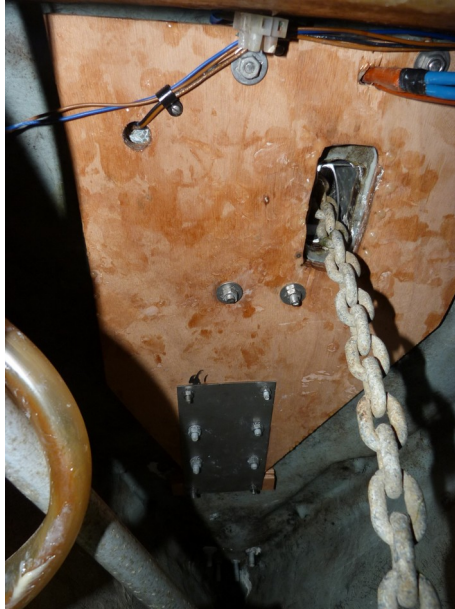
The following picture shows the underside of the deck in the forepeak, with the re-enforcement.

The windlass was mounted where the mooring cleat had previously been situated. Moving the cleat meant putting it over an area where the deck was of balsa core construction, and thus re-enforcement was needed. This was done by gluing 3 layers of 5 mm plywood under the area – using epoxy and bolts to pull it into place under the cambered deck. The cleat was then mounted on a rectangle of stainless, with another underneath, and with additional bolts at the corners of the rectangle. So far the windlass has worked well but its winch drum produced instant riding turns. A new winch drum has been made of a different shape, modelled on other winch drums on the boat, and machined from a solid slug of marine grade stainless. . It works. This issue is was followed up with the makers who said that the winch drum should not be used as a power winch (in which case why have it?). You can use the main halliard now to take a man up the mast (engine running for watts) and make sure you taken the “lifting” end outside of the lazy jacks or you will get a tangle. In theory the same arrangement could pull a man out of the water.

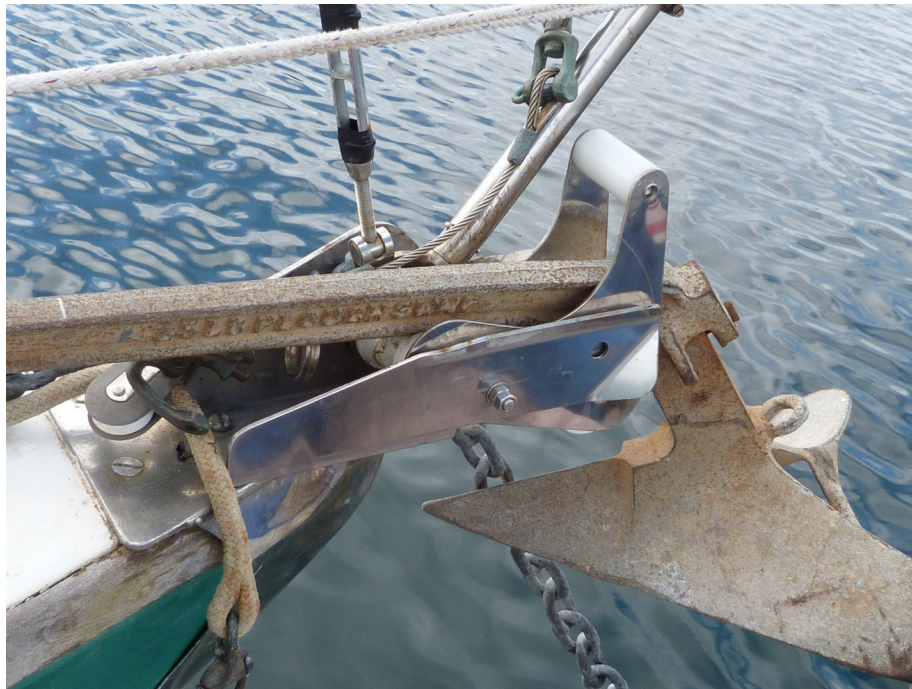
In windy weather there is a danger of abrasion of the anchor warp in this device. A piece of plastic pipe (slit) is in the starboard side cockpit locker and can be fit over the warp at the roller, winding the strings round to tighten it.

And this is the “tippy” device at the bow:

A “tippy” device has been fitted at the bow roller, which has been modified to take it. This was from Plastimo and makes the anchor self parking.

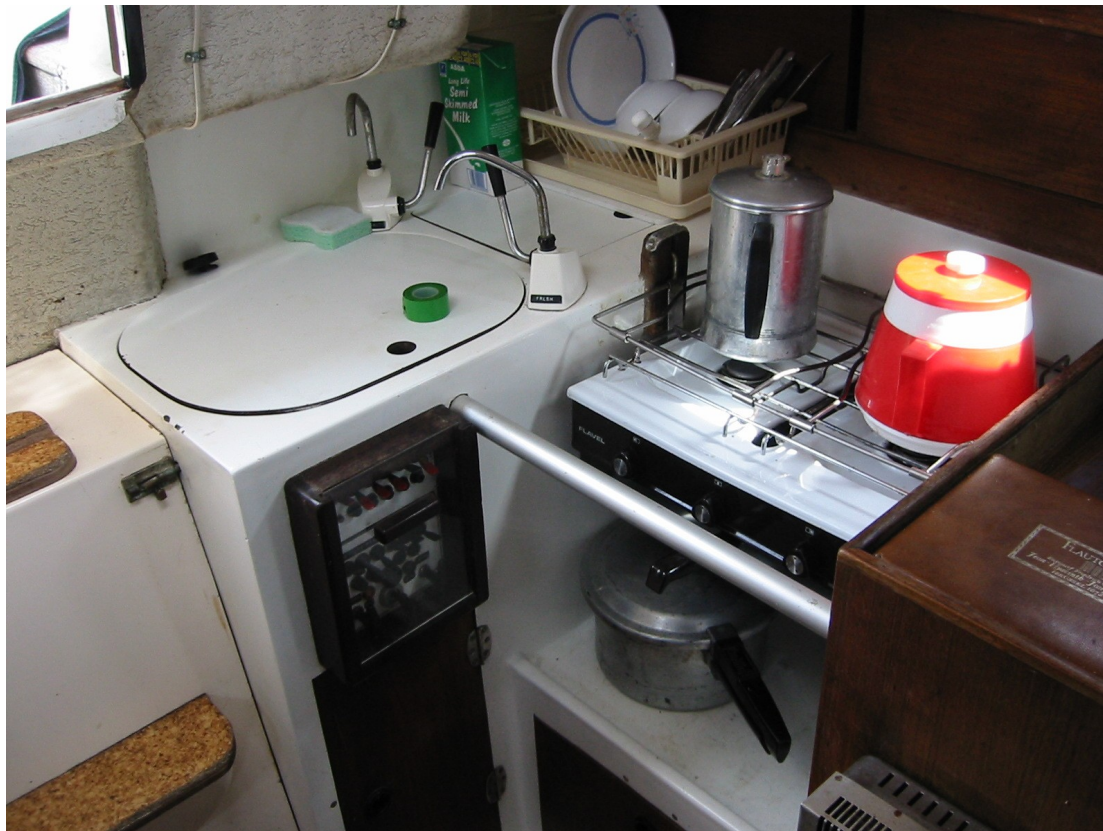
Not fitted by Peter Webster. Once, when bashing into a force 5-6, about 10 miles from the Isle of Man, a young and pretty crew member fell against the stove, which had a pot of boiling water on it. The water filled her Wellington boot. Very luckily she has no permanent scarring, but a crash bar was quickly fit after this. It is simply aluminium tube, inserted through 2 holes. The end of the tube had notches cut in so the ends could be hammered over to make flanged ends.

Note also the aluminium strap over the aftermost cooker pivot – another post “Fastnet Gale” modification. Also frame and Perspex cover over switchboard, to avoid the switches getting knocked off.

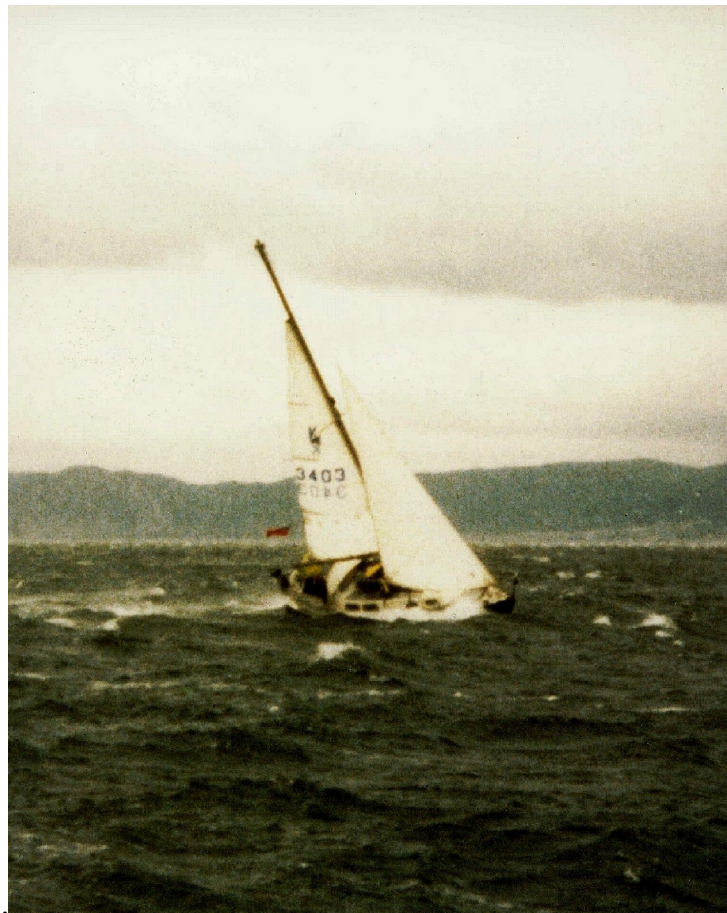
The standing rigging was due for a second renewal. Since the mast had not been out for years, I asked the yard to take it out (then Dickies at Bangor, N Wales). Aluminium rot is not uncommon on keel stepped masts, where they get into the bilge, and I wanted to look at it. To my horror the yard reported the mast as sawn part through. The causes were complex.

The inside of the “spigot” on the deck, where the mast protrudes, had a molded lip on the inside at the top. This “lip” had sawn through my inner tubes and had been happily sawing through the mast. At this point there was a groove covering most of the Port side of the mast and about 2+ mm deep.

Here is a picture of Tantaliza, with her mast sawn part way through, thrashing into a wind rising force 8, that, I am told by people with anemometers, reached force 9, all shortly before this fault was found. Those who have not had to sail E30's into such winds will be consoled to know that “Tantaliza” happily beat up the Menai Strait against this, going like a train into a wind-over-tide sea, and with the final reef in her main, and the old style removable No 2 jib, arriving safe and sound, but with her dodgers blown out. Mr. Thomas is to be congratulated.

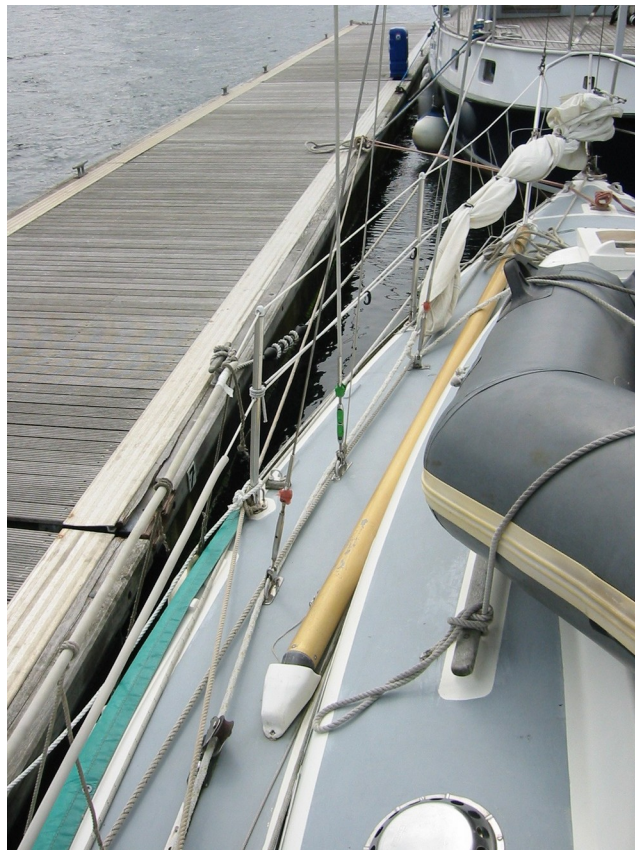
The inner shrouds at this time were attached to the coachroof side, though the cap shrouds are fixed half way out across the side deck, with large knees moulded under them at the cabin bulkhead. The angle made by these inner shrouds at the mast was tight, and even with a lot of shroud tension, when at the mast, reefing, with the boat punching into a sea and the main flapping, you could feel the mast shake.

The new arrangement looks like this from above:

The next thing was to improve the angle of the shrouds. I did not want to move everything outboard to the gunwale, but to bring the inners in line with the cap shroud at deck level.

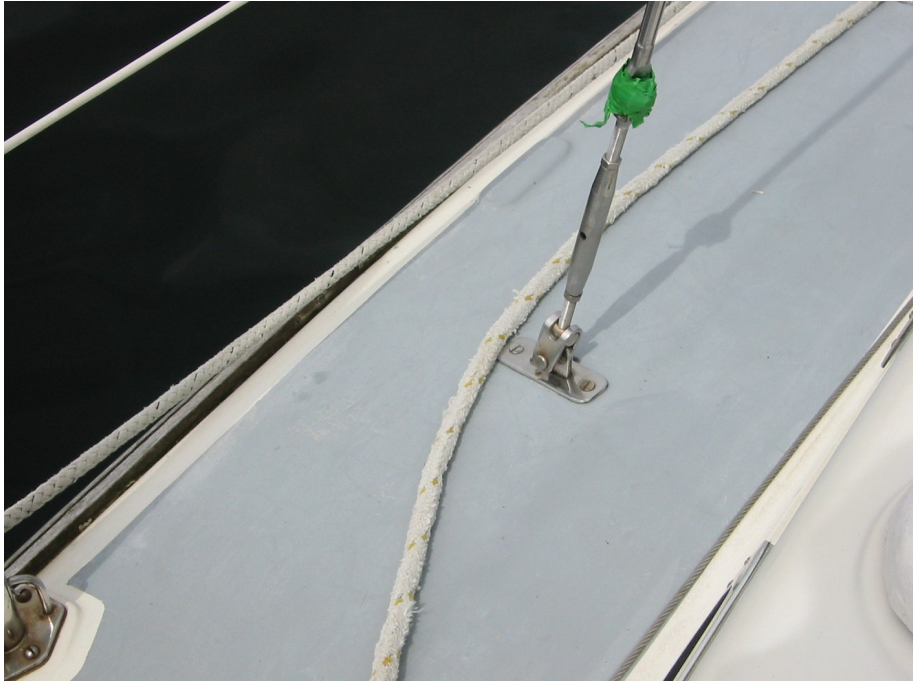
The forward chainplates were relatively easy, being taken down the bulkhead between the loo compartment and fore-peak. This brings them a little forward of the original position, reducing the angle through which the spinnaker pole can swing. However we do not race, and for cruising with spinnaker, the present arrangement is good enough. See below for the fitting at deck

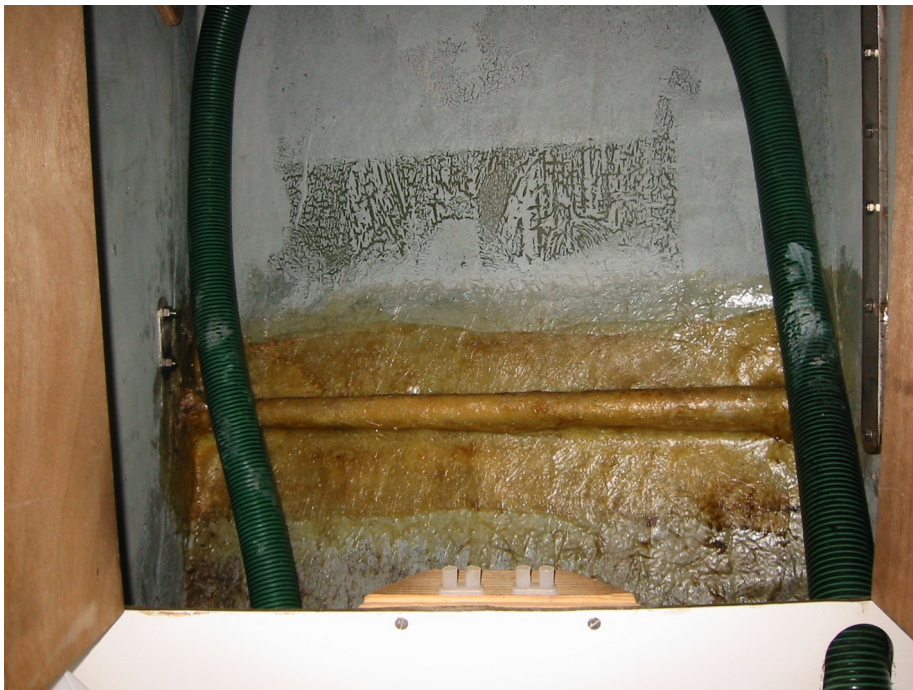
Arrangments below consist of a chain plate down the bulkhead (R.H.S. of this picture):

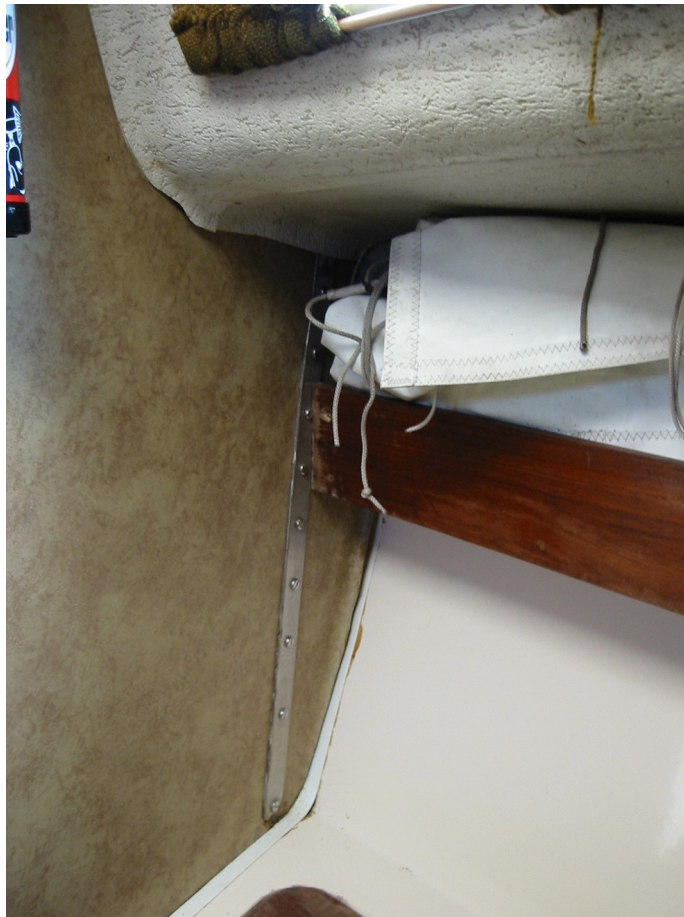
This is backed up by a strip on the other side:

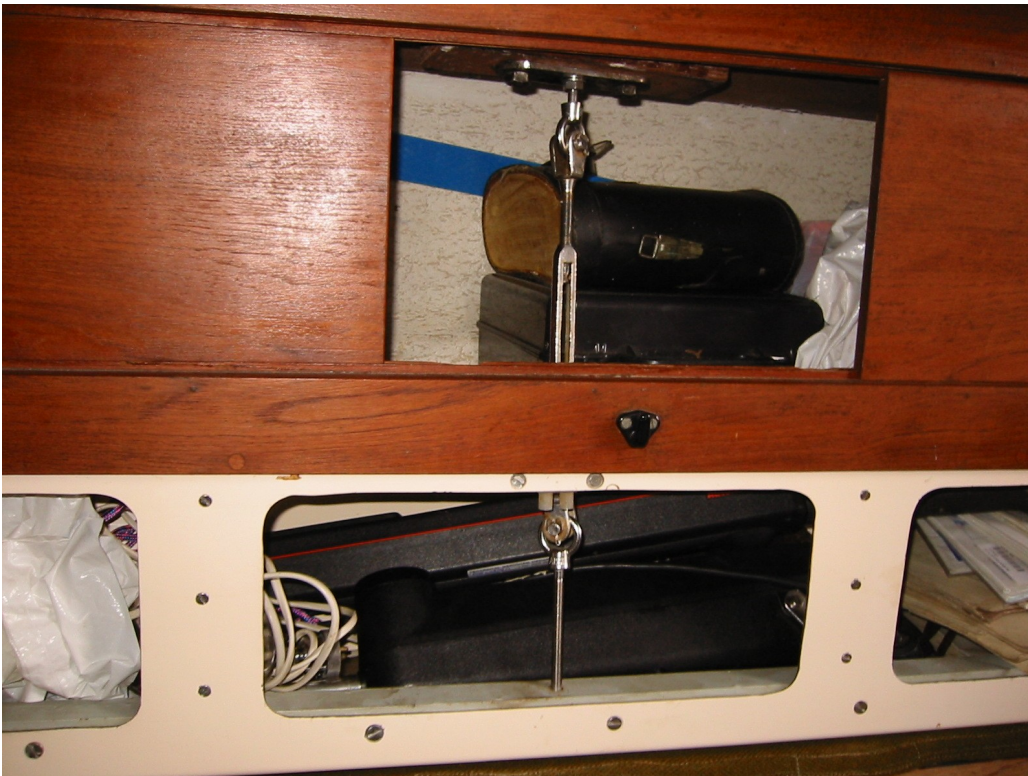
To provide a little additional stiffness, I tried to bring the locker construction into play. The bottom edge of the lower locker is now backed up by 2 lengths of angle iron, assembled to make a “U” section channel, duly epoxy coated. This is bolted at the ends into the bulkhead (forward) and the ply end of the locker “block” aft. (look 2 pictures up and you can see the backing plate from this, on the left.). This is still slightly psychological, since the “U” section bar will easily flex. I tried to use the whole locker box . Realising the small vertical strips in the lower locker will go into thrust, and since they are only thin and could “trip” under load, they were backed up by wooden blocks. You can see the screw heads in the following picture. The whole thing is tied down by a second rigging screw underneath, as the picture shows. This rigging screw simply passes through a hole in the bottom of the upper locker.:

I simply bolted two “U” bolt type chainplates through the deck at side. However this was after stiffening up the deck underneath by fitting two thicknesses of 1” ply, three feet long, glued together. They were put in place, and the whole thing then tightened. After this, silicone sealer was smeared all around the edges where these “boards” met the deck. Holes were then drilled in the deck above and the whole area was flooded with epoxy resin. This includes the voids between the board and the underside of the deck, and the sandwich construction itself.

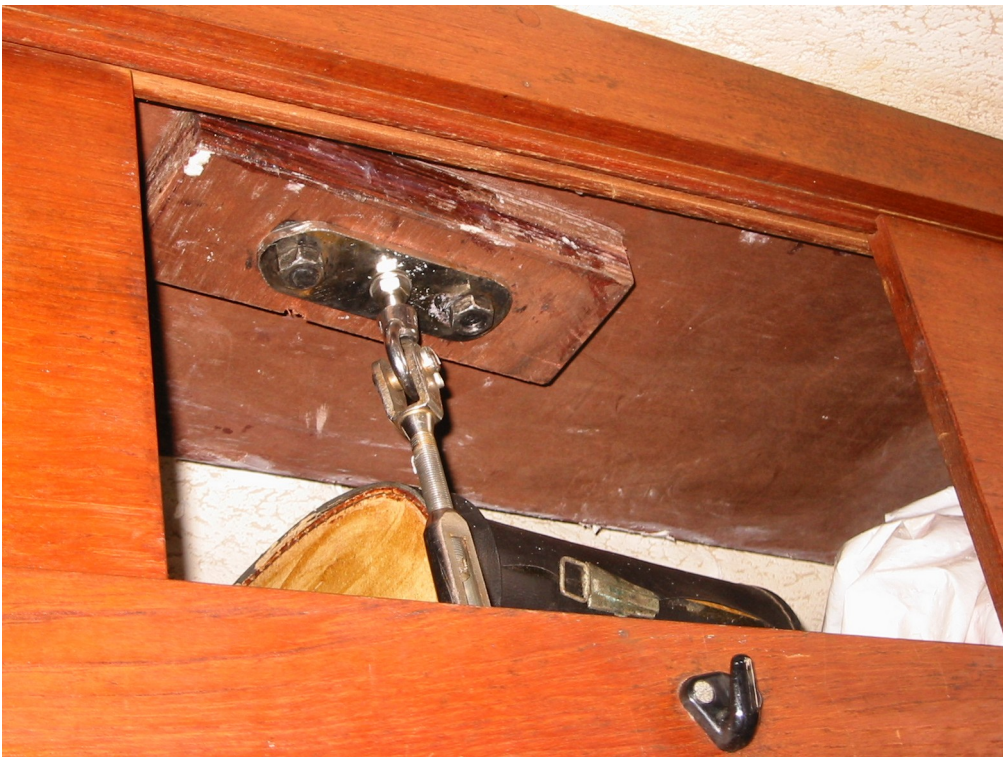
The next picture gives a closer view of the doubling under the deck (the small wood pad brings the thickness to 3" at this point)

There is no evidence of any flexing in this area, and it is amazing how the tension on the inner shrouds has been reduced, with no slackening of the lee shroud, and the mast now firm and solid.

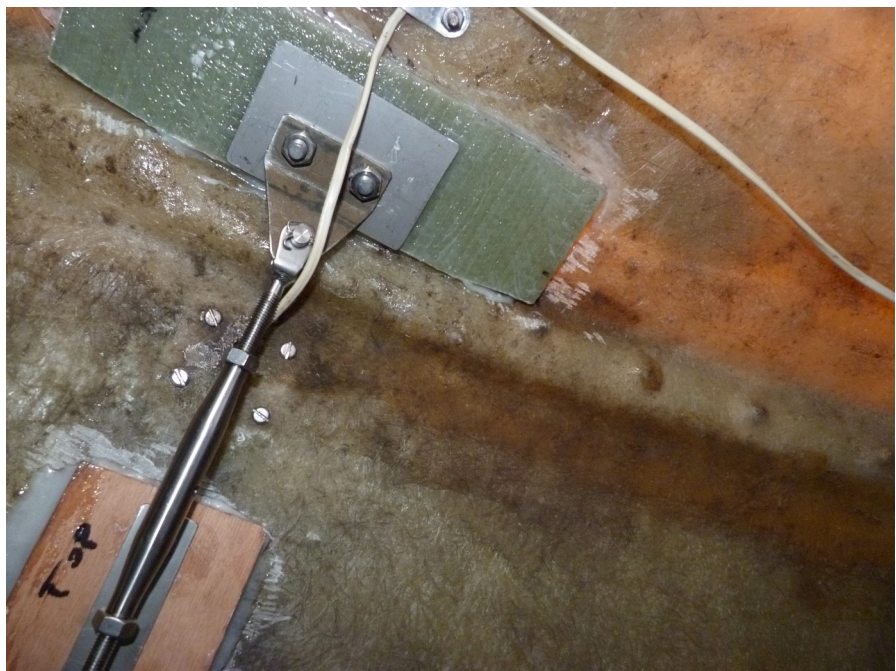
In 2015 cracks appeared in the deck around this. On examining it more closely, this arrangement should have given Mr. Thomas the horrors. The cracks seem to be in the gel coat, not all the way

through but the yard said this needed attention. There seemed some thin doubling on the deck in the area plus lots of GRP underneath but nothing like a chain plate to take the load. Pretty tacky – how has it held up? (The yard say this is nothing compared to what they do with modern boats).

The following picture shows the underside of the deck after the modification:

A slab was bought of a material resembling a thick sheet of GRP lay-up. The underside of the deck in this area was ground, as was a vertical “strip” area on the inside of the transom

This slab was the bonded in place under the damaged deck using a lot of thickened epoxy (the surface on the under side being very uneven). A strip of plywood 15mm thick was bonded down the inside of the transom. A new “U” bolt with longer “legs” was put in with plate behind this and behind that a stainless “tab” with a hole in it. A further stainless strip was bolted down the inside of the transom over the plywood. A second stainless “tab” was bolted over this, and the two connected with a rigging screw, screwed tight.

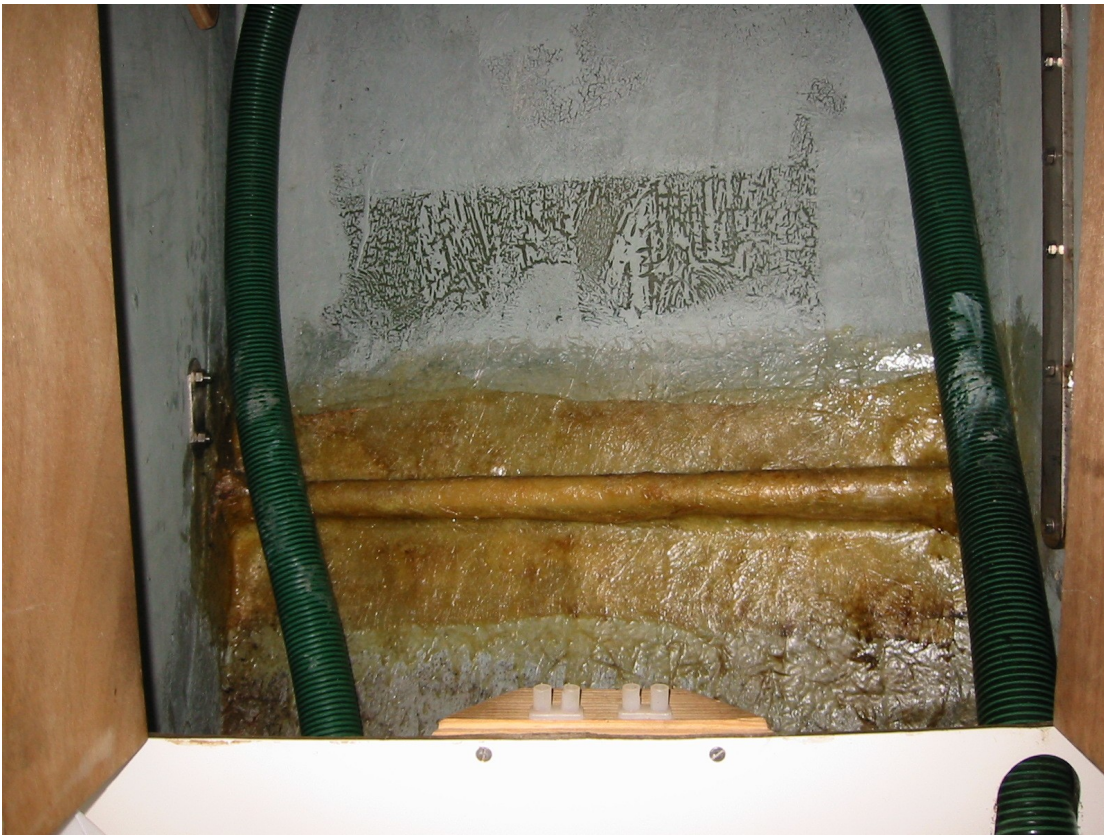
Angelsey, where we used to sail, is surrounded by strong currents and a number of races, greater and lesser, which you sometimes have to beat through. On occasion she has fallen off a wave onto her lee bow with a “crash” that sounded more like you had landed in the middle of the M1 from a height of 100 feet. Most boats of this era have a longitudinal stringers molded in. The E30 does not, though the furniture provides some degree of stiffening forward. However in the 2 lockers in the loo compartment, there is no longitudinal stiffening between the keel and the deck. Here I glassed in pieces of wood, Port and Starboard, to stop “panting”. I repeat the previous picture:

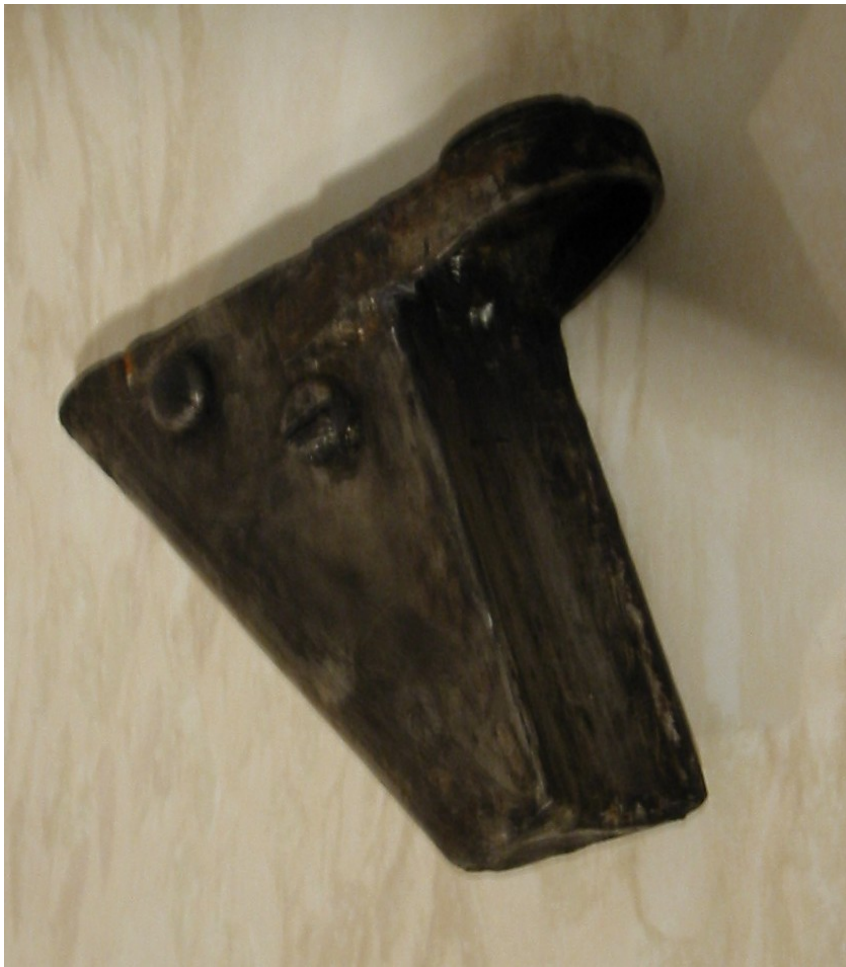
The Peter Webster type had the rudder supported on a simple stainless tab, sticking out at the back, with a hole for the bearing. This looked flimsy.

I have beefed this up by taking a strip of stainless about 3/4 inch wide, bending it to a "U" shape, and welding it around the edge of the existing support, so that this old support has a sort of flange at its lower edge – ends welded back to the main support at the base of the skeg. Pic taken after removing fitting during scraping of old antifouling. The original nylon bush was replaced with a piece machined in Tufnol.

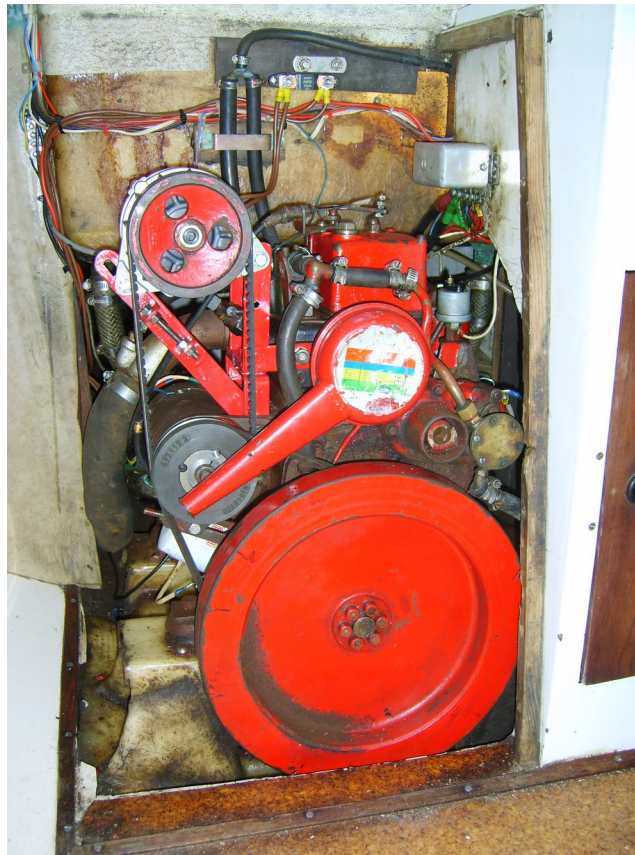
An alternator was added in tandem with the dynastart. The picture should be self-explanatory. The double belt wheel on the dynastart (with “taper-lock”, centre machined out to reduce thickness by 5 mm to allow for available shaft length) is somewhat smaller in diameter than the original wheel, which will increase the revs somewhat. The wheel on the alternator is the original wheel of the dynastart. This is the job complete.

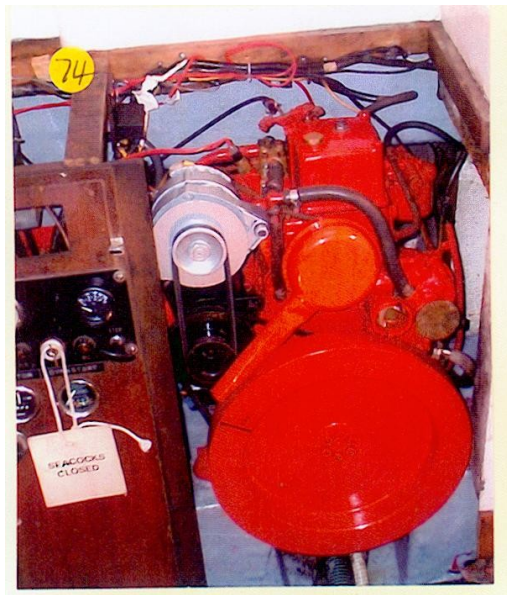
Bukh used to sell a conversion kit to do this but that was aeons ago – dimensions of original double wheel wheel somewhat different. The following pic shows a Bukh conversion job, NOT OURS, courtesy of an EOA member:

- Much tidier but I could not source a double wheel where the INNER aligned itself with the flywheel – hence the “Eiffel Tower“ arrangement I have made.

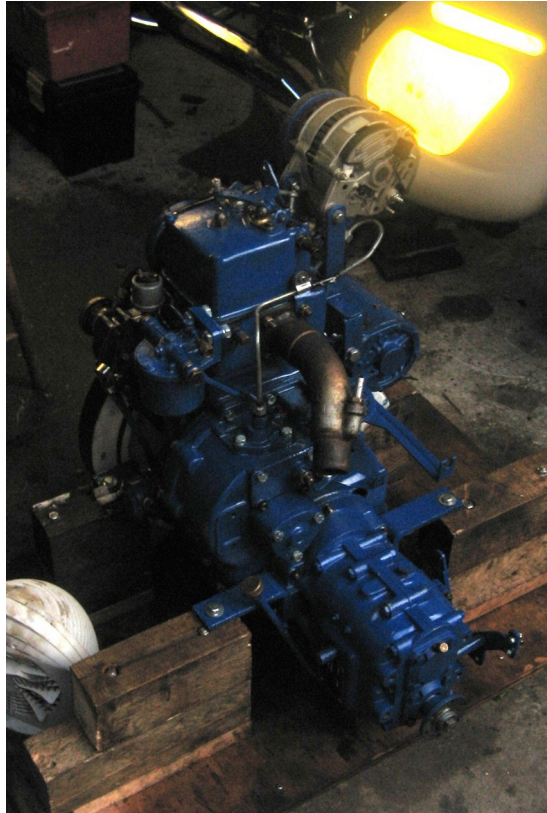
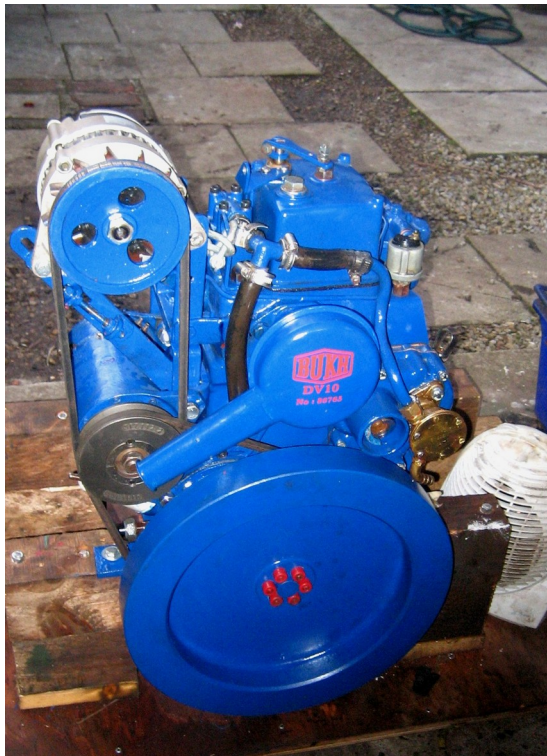
See pics

New piston (**very** worn with a broken ring!)

Its running like a top. Also no oil consumption and about 4 hrs to the gallon of fuel.
